Manhole Inspection Summary

Manhole # S29GG_020MH

Location Address: **236 MASON ST**

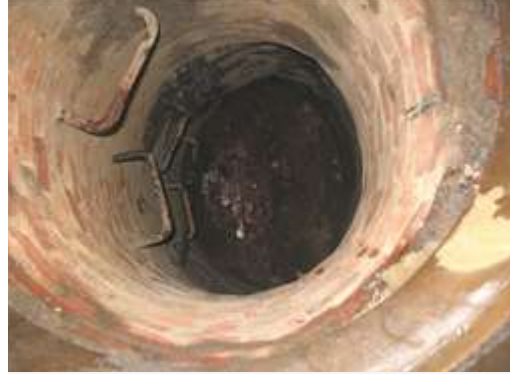
Top View

Frame leaks. Frame offset. Adjustment deterioration and infiltration. Barrel infiltration. Channel debris.

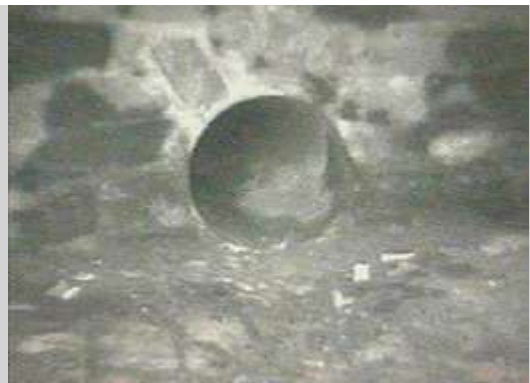
Pipe Out @ 12 O'Clock

Infiltration: **Evidence**
